**CITY OF STANWOOD
CITY COUNCIL
AGENDA STAFF REPORT**

SUBJECT: City Hall/Police Remodel - Update	FOR AGENDA OF: DEPARTMENT OF ORIGIN:
ATTACHMENT(S): A. City hall schematic drawing B. RMC Scope of Work C. Deliverables Update D. Kingworks Police Visit E. AWA Police Report F. Rice Police Report G. Knebel Police Building H. Kingworks City Hall Visit I. AWA City Hall Report J. Rice City Hall Report K. Knebel City Hall Building	DATE SUBMITTED: CLEARANCES: (check box) <input type="checkbox"/> City Attorney _____ <input type="checkbox"/> City Clerk/HR _____ <input type="checkbox"/> Community Development _____ <input type="checkbox"/> Fire _____ <input type="checkbox"/> Finance _____ <input type="checkbox"/> Police _____ <input type="checkbox"/> Public Works _____ APPROVED FOR SUBMITTAL BY THE CITY ADMINISTRATOR: _____
COST OF PROPOSAL: N/A	AMOUNT BUDGETED: \$40,000 city hall space study \$45,000 city hall retrofit – lights, doors, etc. \$-0- police station

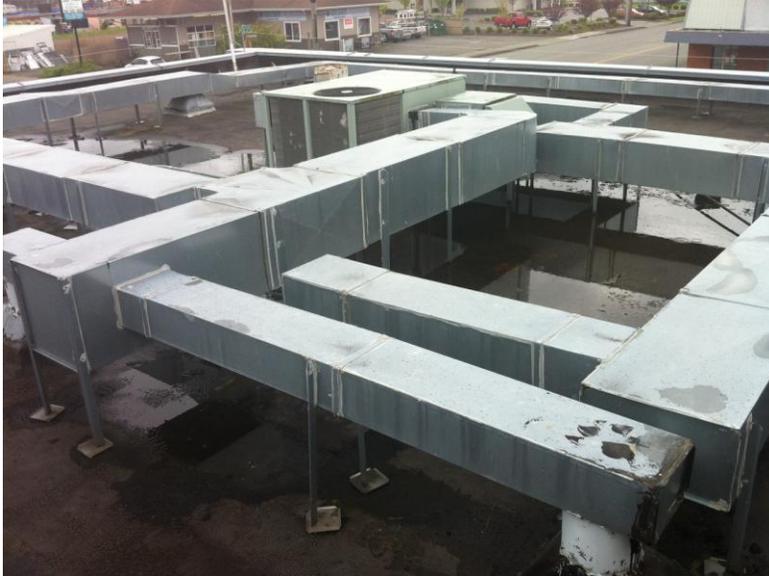
The main ground level is heated and cooled by a gas fired air conditioner (Rheem RKKA A072CL13E 6 ton AC, 109,000 btu/hr gas heat) located on the roof of the building. The mezzanine is heated and cooled by a split system heat pump (HP8 413 1FFL). Both the

roof top air conditioner and the split system heat pump are old and have already exceeded their expected life. The Roof Top Air Conditioner is ducted to the first floor by exposed ductwork on the roof. With a re-roof imminent, it makes sense to relocate all the ductwork inside of the building rather than on the roof.

Roof Top AC and Ductwork

1) Replace Rooftop AC and Ductwork for Police Station	\$30,000
2) Add Rooftop AC and Ductwor for Annex	\$25,000 (excludes electrical)
3) Replace all plumbing	\$25,000 Total
4) Provide Sprinkler Coverage	\$40,000 (includes upgrade from street)

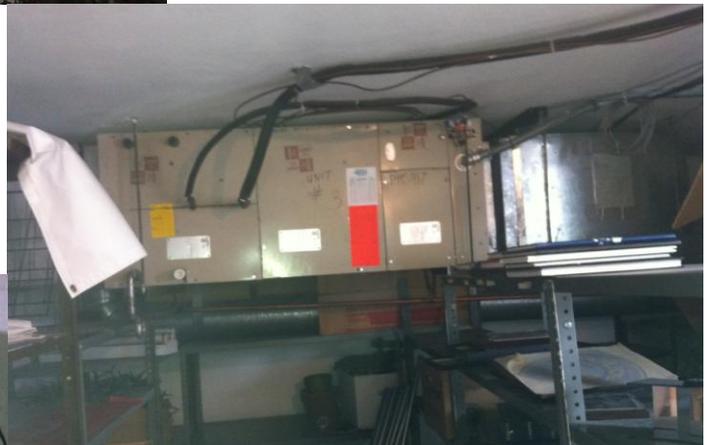
Mezzanine Heat Pump

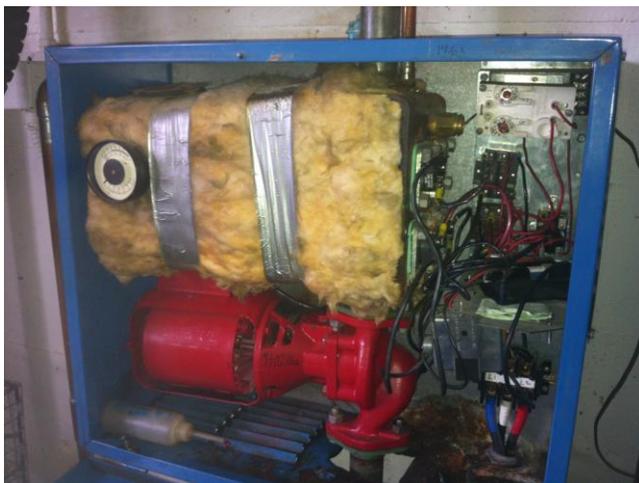
The Annex appears to be heated by a small electric boiler (General Machine EB3C12). This boiler has been disabled since it was leaking water and the cost of the water/sewer bills was high. We would recommend the installation of a Packaged Heat Pump for cooling and heating the Annex.

Annex Boiler

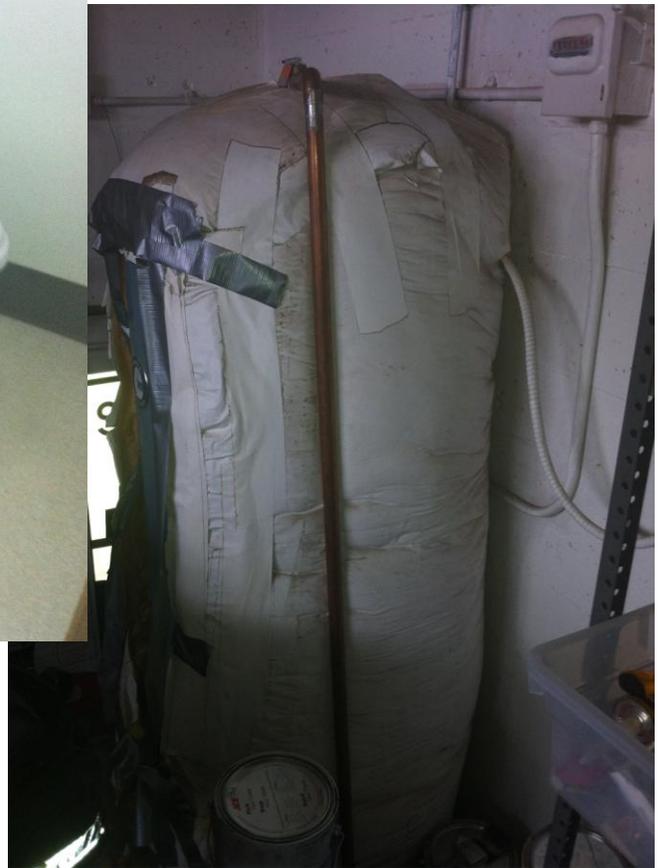
The hot water heater is an electric 40 gallon storage type heater and is located in the back room. It was covered with aftermarket insulation and we could not determine the age..

Water Heater

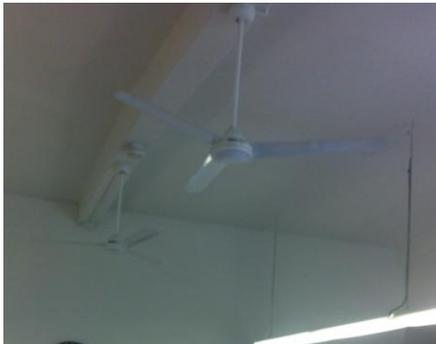
The building has no air conditioning. We did not verify if these fans were operating. However, usually they are noise and not used or not serviced over time.

Paddle Fan

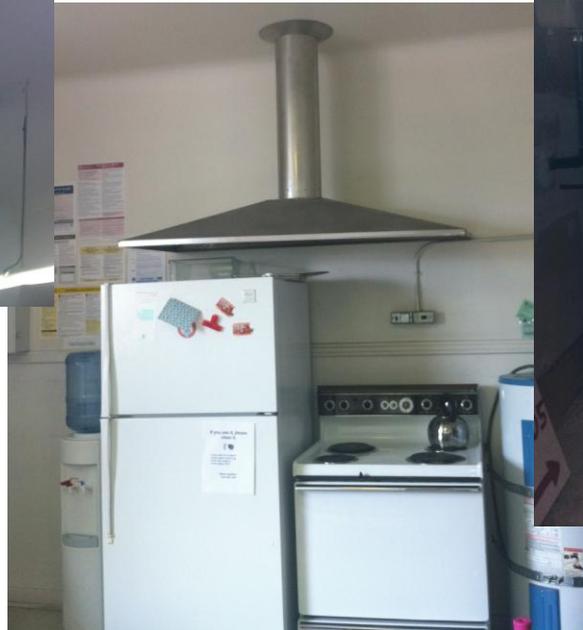
The break room has a residential style oven/range top. Above the oven/range is a built up hood. The hood does not provide full coverage of the oven/range. Again we question if this hood is operable or if it is if it is ever used. Based on codes residential hoods can only be used in single occupancy residence. Thus, this hood would have to be classified as a type I or type II hood. We do not feel it would classify as either.

Kitchen Hood

- 5) Again, though not technically a deficiency, there is no air conditioning. This is very uncommon in public facilities today.
- 6) The kitchen hood is too big and covers far too much area. Also, it is probably not up to current standards.

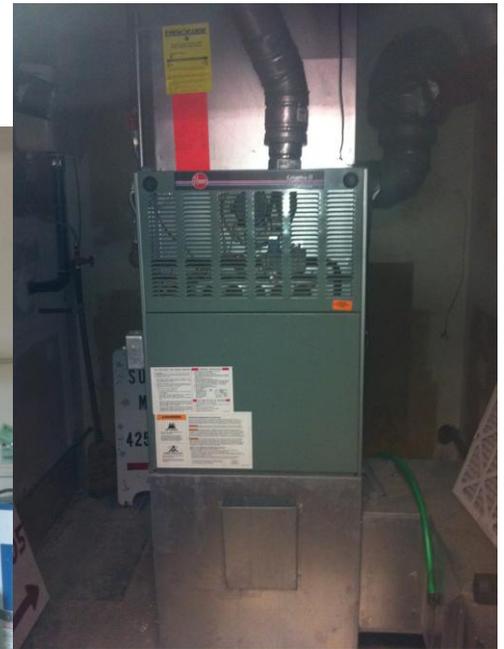
The facility is heated by two gas fired furnaces. One is located downstairs in a closet (Rheem RGPH 12EARJR 125000 btu/hr) and one is located in the attic (Rheem RGLH 12EARJR 125000 btu/hr) Both furnaces are relatively new and in good condition. However, neither has any outside air for ventilation ducted to them. In several of the larger rooms there are several paddle fans (clearly an attempt to provide some cooling)

Gas Furnace

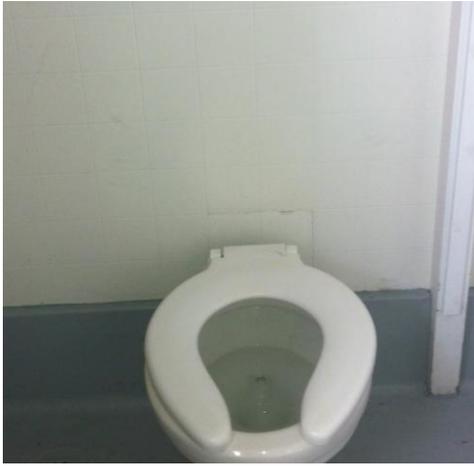
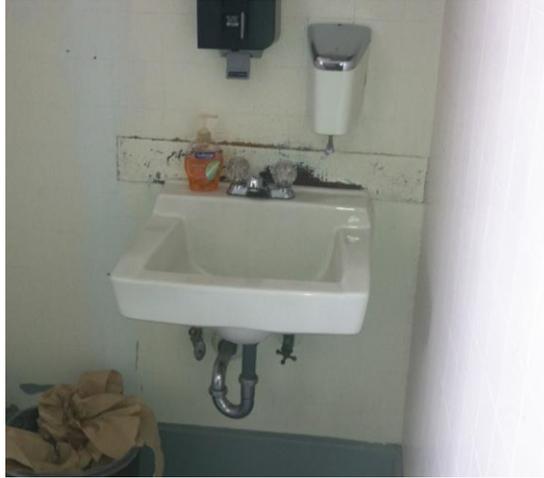
Plumbing Fixtures

- 3) The plumbing fixtures are out of date...literally by 50 years. The whole plumbing system is inadequate. The water heater is poorly located. The galvanized piping is not recommended any more for water systems.

| 3) Replace all plumbing | \$30,000 Total |

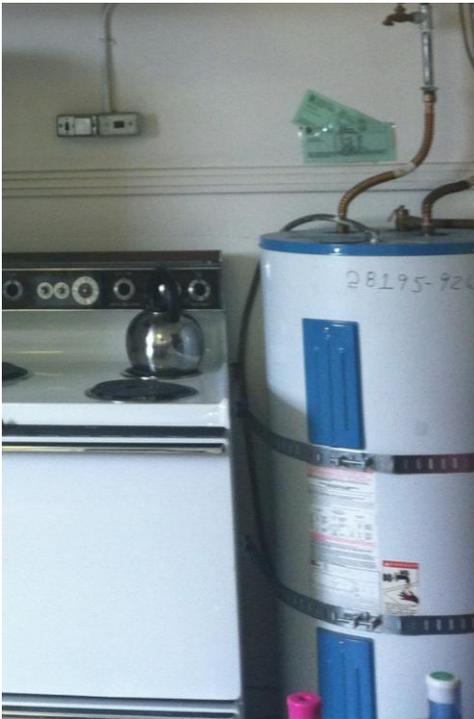
The hot water heater is an electric 40 gallon storage type heater and is located in the break room. The location of this water heater in the break room while acceptable by all local codes is just not a standard location for water heaters.

Water Heater in Break Room

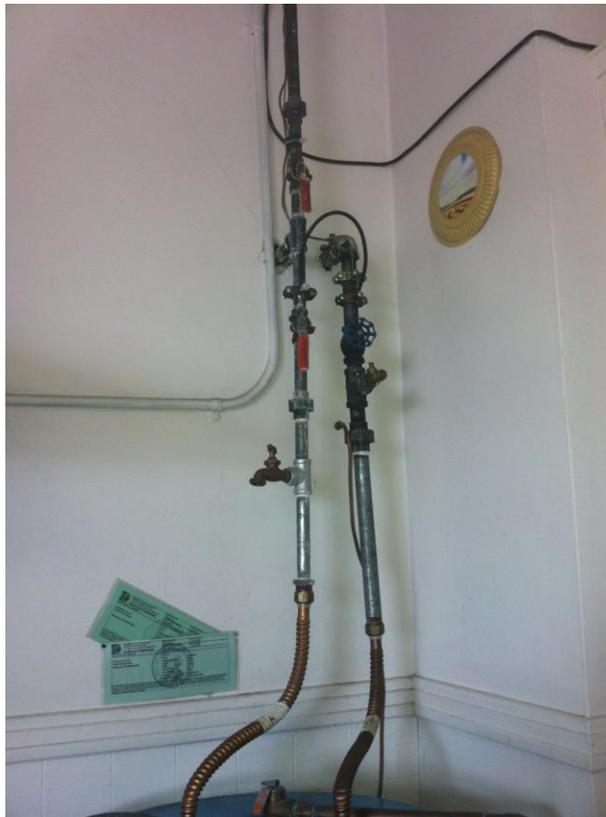
The hot and cold water system is mainly galvanized pipe, with new additions being made in copper. No dielectric fittings were seen so the copper to steel connections will deteriorate with time. The RICE Group's, experience with galvanized pipe is that it tends to corrode by developing deposits on the inside of the pipe which will eventually totally obstruct the pipe. However, we did not observe any reduction in pressure in the building.

Piping (copper, and galvanized)
