CHAPTER 6

DEVELOPMENT OF CAPITAL IMPROVEMENT PROGRAM

6.1 STORMWATER INFRASTRUCTURE PLANNING PROCESS

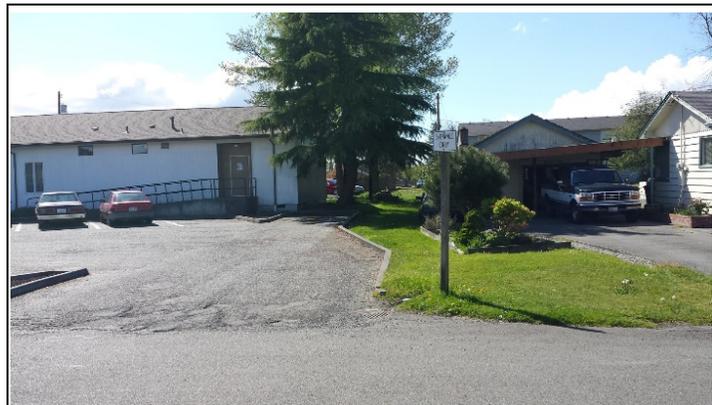
Figure 6-6: Area of Flooding Adjacent to Library

Low area adjacent to Library that floods due to limited Irvine Slough capacity.

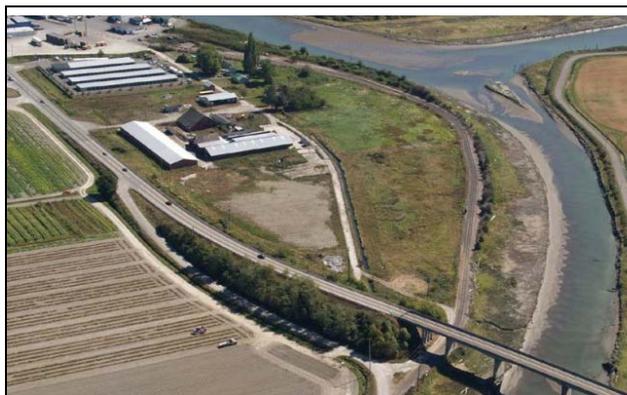
Figure 6-7: CIP Project #1 – Site of Potential ISSSP Pump Station

Potential ISSSP Pump Station Site to the west of Twin City Foods, taken from the west.

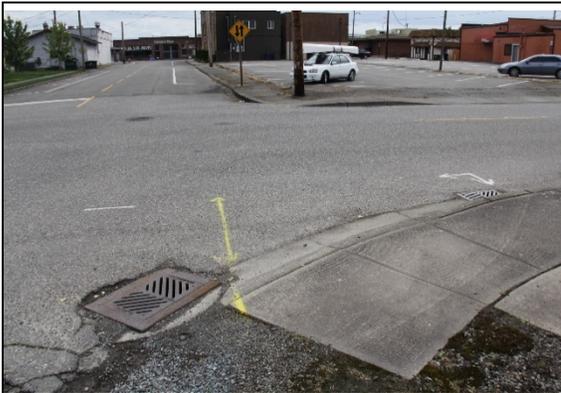
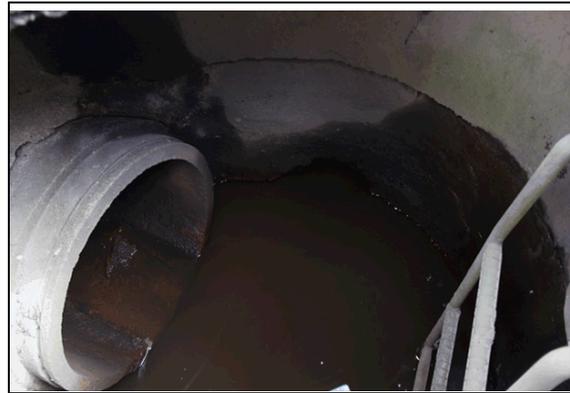
Figure 6-11 CIP Project #3 – 271st Street NW Photos

Photo looking south across 271st Street NW at 101st Avenue NW, location of 8” pipe limiting capacity.

Photo of catch basin ID #40 at intersection of 271st Street NW and 101st Avenue NW showing 24” and 8” pipe in same structure (May 26, 2014).

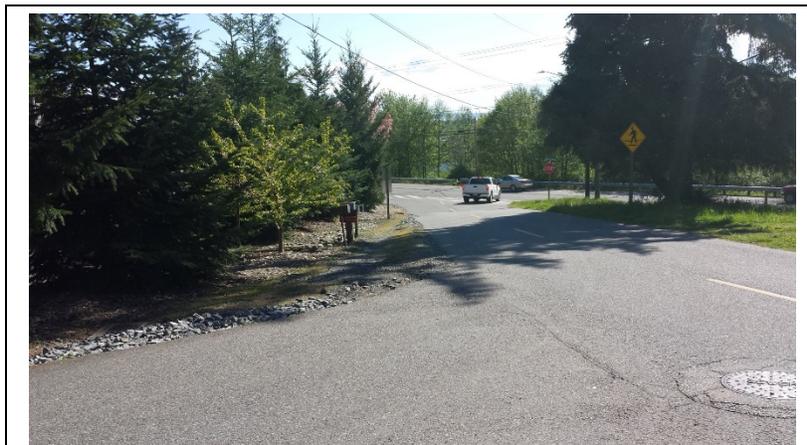
Figure 6-15: CIP Project #4 – Looking South Along Proposed Ditch Alignment

Looking south along proposed ditch alignment on 276th Place NW from 85th Drive NW (April 25, 2014).

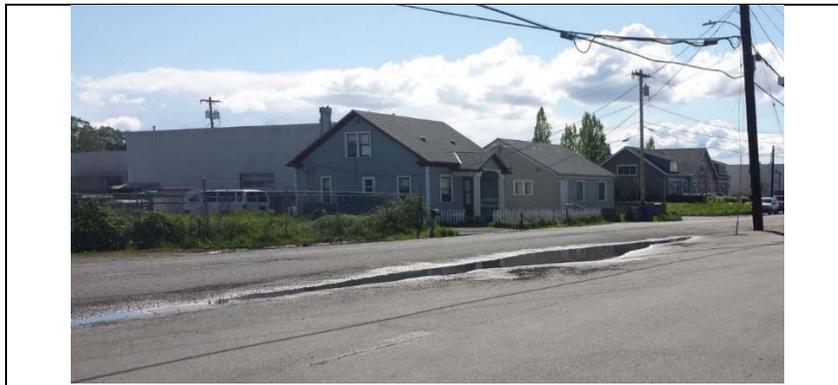
Figure 6-17: CIP Project #5 – Looking West Showing Some Surface Ponding

Photo looking west along 270th Street NW from Florence Drive, shows some surface ponding at shoulder of roadway (April 25, 2014).

Problem Description: The storm drainage system on 270th Street NW, between 88th Avenue NW and Florence Drive, is ineffective at collecting runoff from the right-of-way and surface ponding occurs frequently as a result (see an example of such ponding in Figure 6-17 below). Additionally, there is at least one pipe that is crushed and in need of replacement which crosses 270th Street NW near 87th Avenue NW.

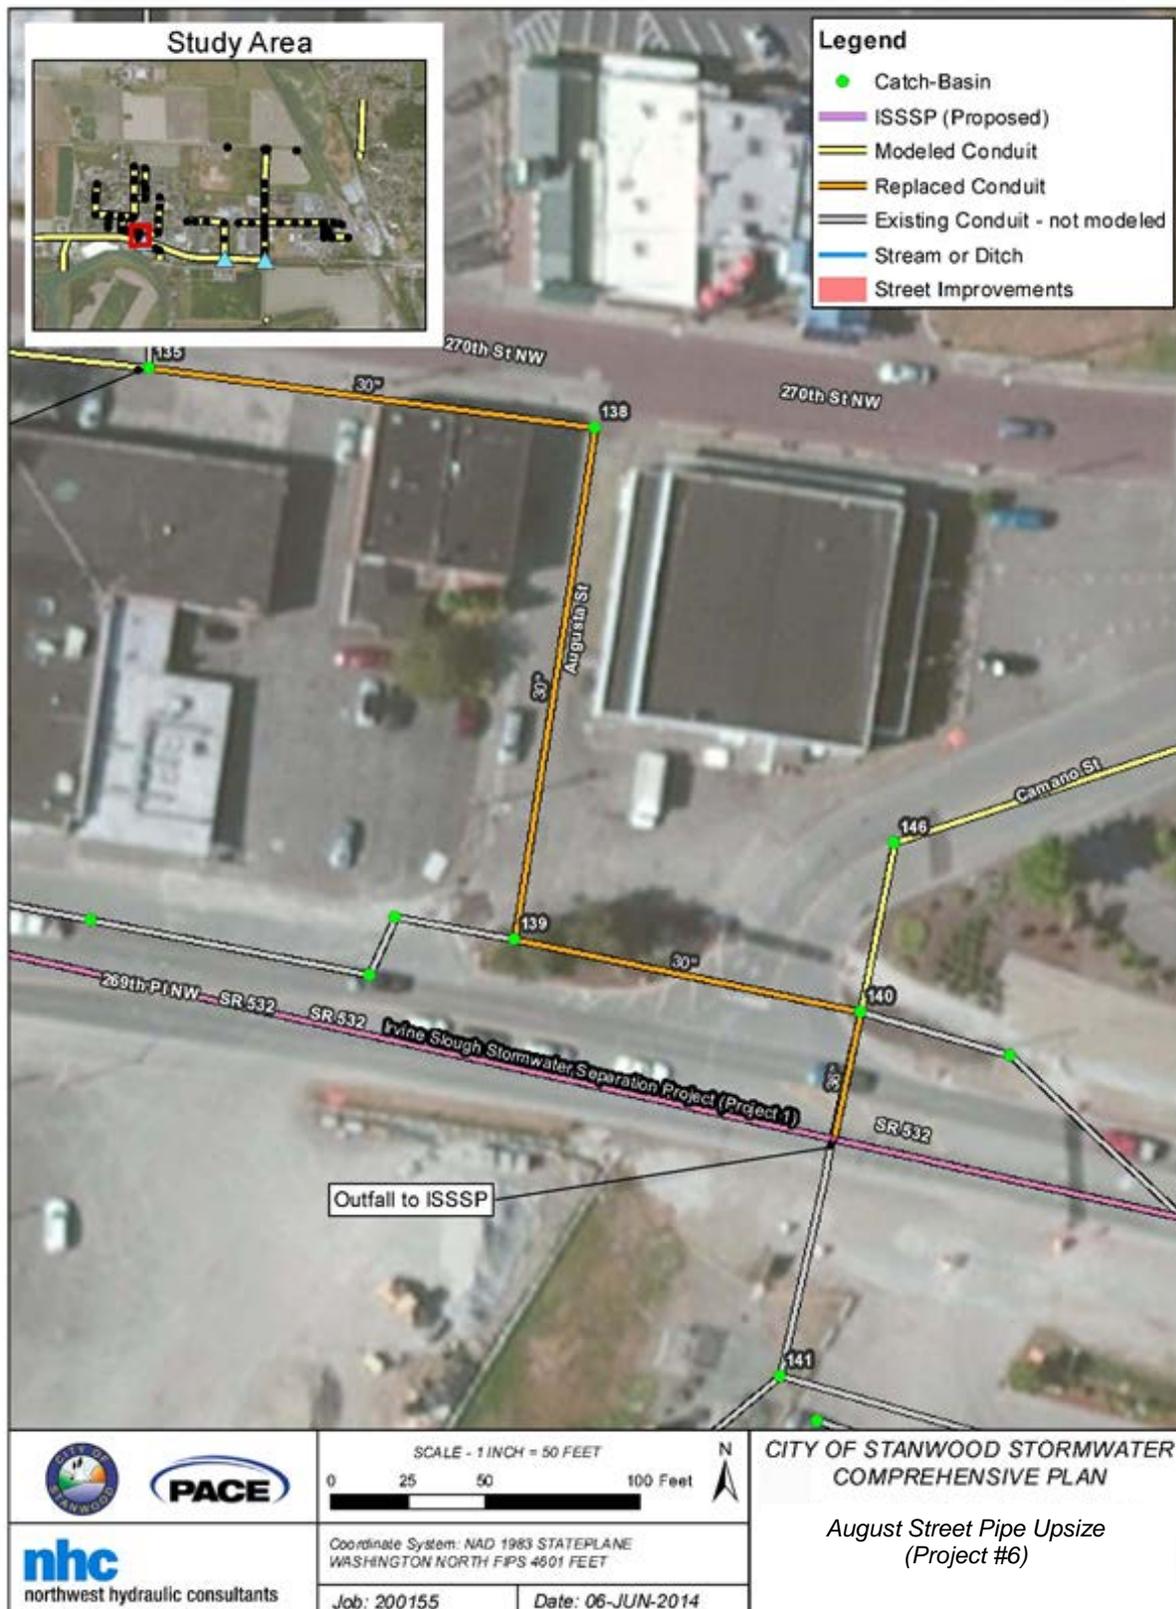
Figure 6-20: CIP Project #6 – Augusta Street Pipe Upsize

Problem Description: This project is an extension of Project #3. Project #3 will improve the capacity of the system and eliminate some of the flooding along 100th and 101st Avenues NW, but some locations at the northern ends of 100th Avenue NW, 101st Avenue NW, and 103rd Drive NW will continue to flood during the 25-year flood. The existing hydraulic profile along this reach is shown in Figure 6-20, with Project #3.

Project Illustration Map: See Figure 6-20.

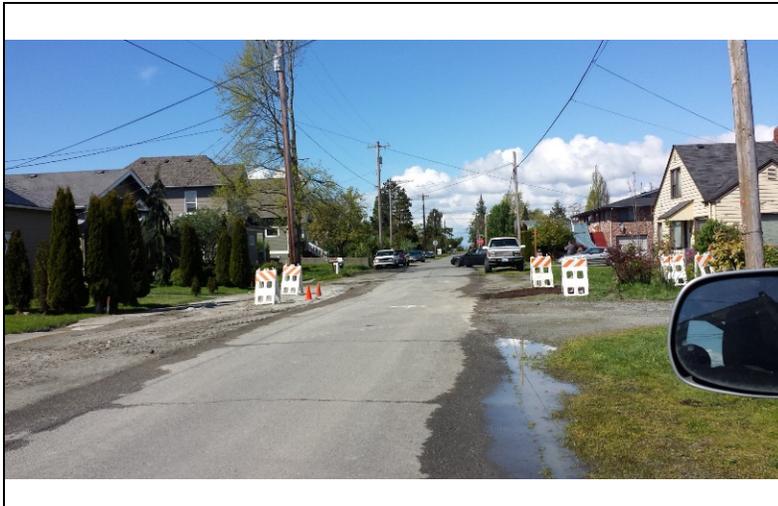
Figure 6-21: CIP Project #7 – Photos

Problem Description: The collection systems in several streets in the west end of downtown Stanwood (101st Avenue NW, 102nd Drive NW, and 103rd Drive NW) are not effective at preventing flooding of streets and yards because runoff cannot reach the stormwater system. Even in locations where the system has available capacity, a flow path does not exist for ponded water to get into the stormwater system. Figure 6-21 shows ponding on the shoulder of 101st Avenue NW and an example of a catch basin that is not able to capture runoff from the roadway. More substantial ponding than that shown in Figure 6-21 was observed in these areas by City staff during the January 2014 storm events.

Photo looking north on 101st Avenue NW from vicinity of 271st Street NW (April 25, 2014).

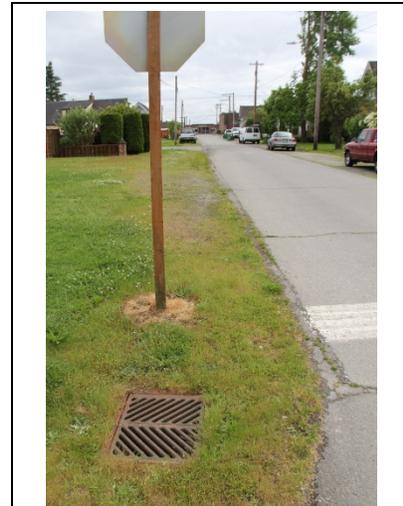
Photo looking south on 101st Avenue NW from 272nd Street NW (May 26, 2014).

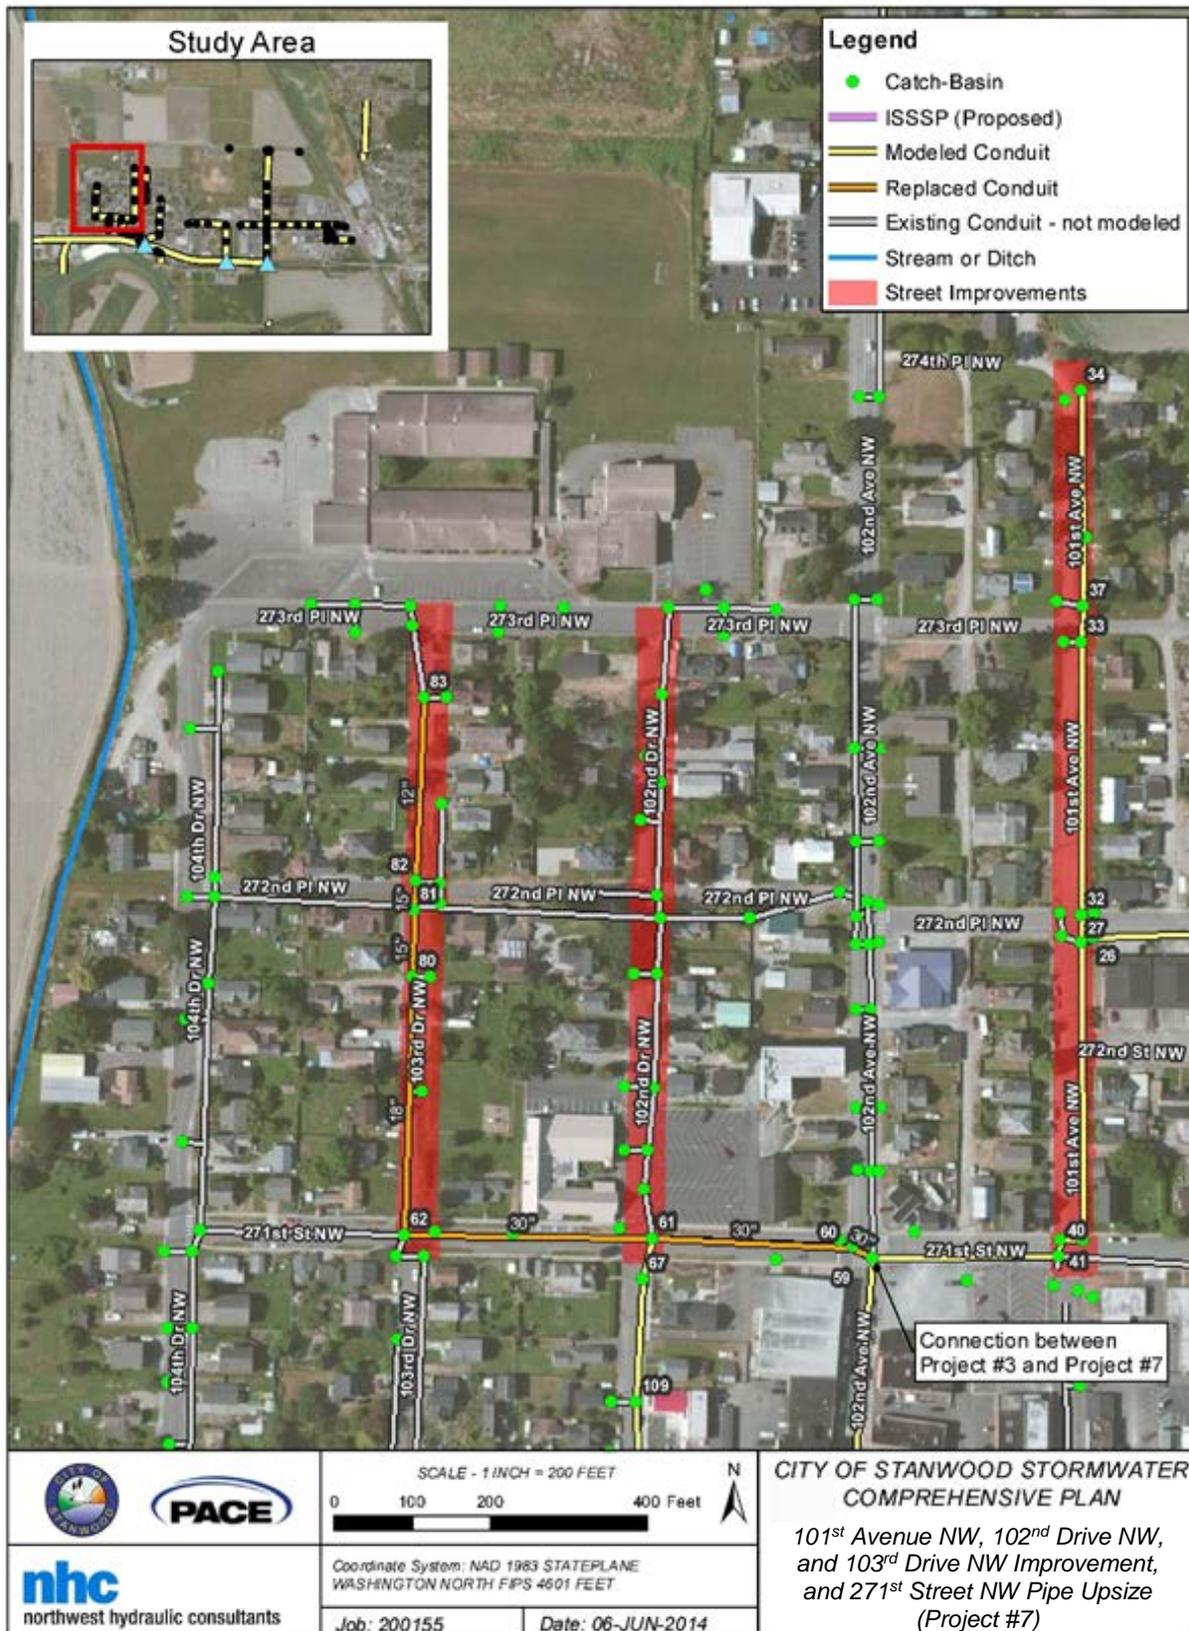
Figure 6-23: CIP Project #7 – Illustration Map

Project Description: Under this project, local drainage improvements and road resurfacing will be performed on 101st Avenue NW, 102nd Drive NW, and 103rd Drive NW. Modeling of these portions of the system shows that additional pipe replacement is also needed to provide capacity in the 103rd Drive NW conveyance system. Thus, pipe replacement would need to be performed along 103rd Drive NW between 273rd Street NW and 271st Street NW under all ISSSP designs. In addition to replacing the pipe on 103rd Drive NW, the existing pipe along 271st Street NW also needs to be replaced to prevent street flooding in the higher 4-foot water level ISSSP design scenario. (Note: The 271st Street NW pipe replacements are not needed if the ISSSP design keeps water levels below the pipe invert at the system outfall. Pipe replacements along 271st Street NW are included in the cost estimate as optional. The 103rd Drive NW and 271st Street NW pipe segments are highlighted in orange in Figure 6-23.)

Project Illustration Map: See Figure 6-23.

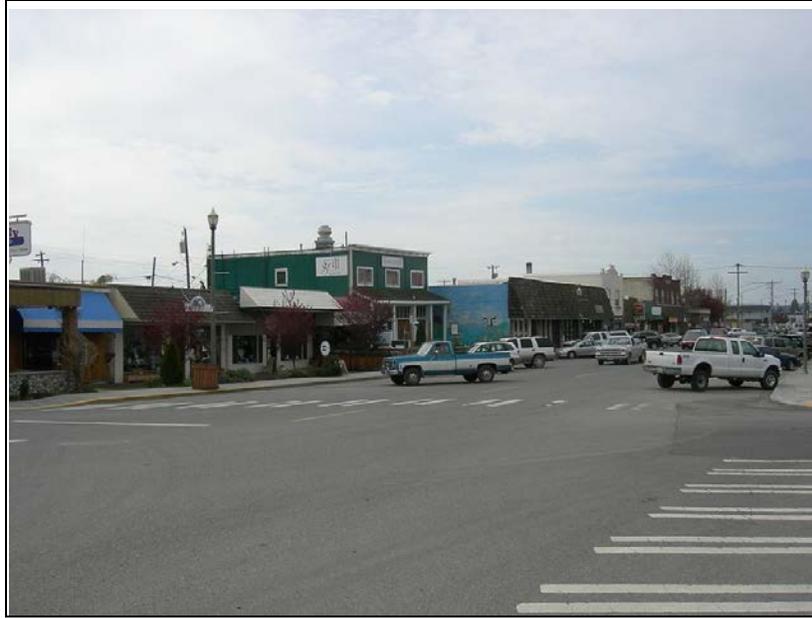
*271st Street NW (Main Street), looking west from Florence Drive
(Photo Courtesy of Joe Mabel).*

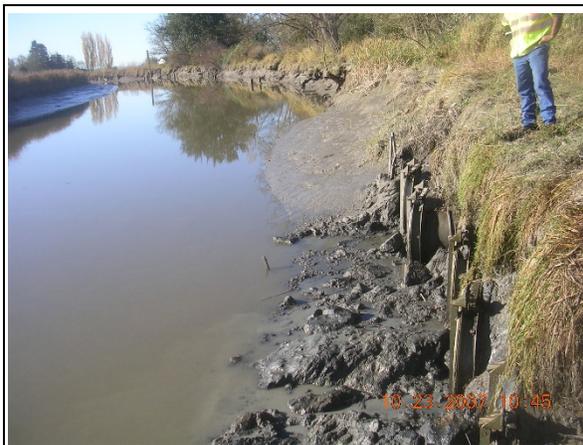
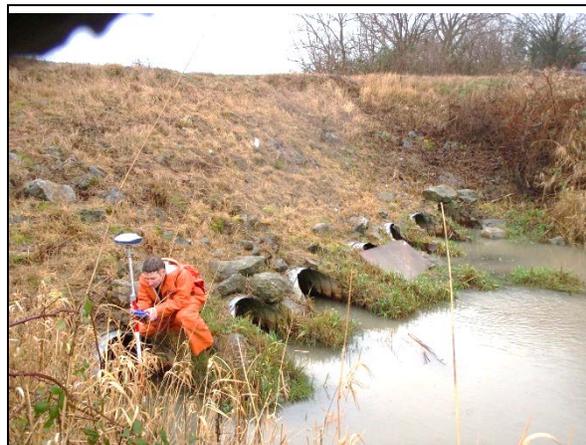
Figure 6-27: 7 Tiny Tubes – Photos

*Outlet of 7 Tiny Tubes, Photo taken
October 23, 2007 (Photo courtesy City staff).*

*Inlet of 7 Tiny Tubes, Photo taken
January 8, 2013 (NHC).*

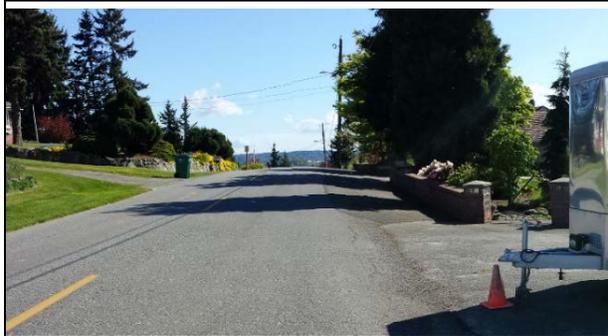
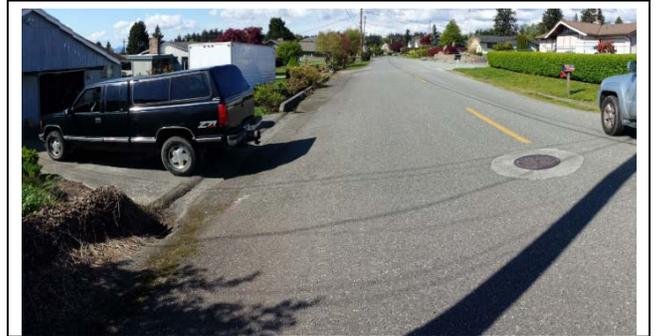
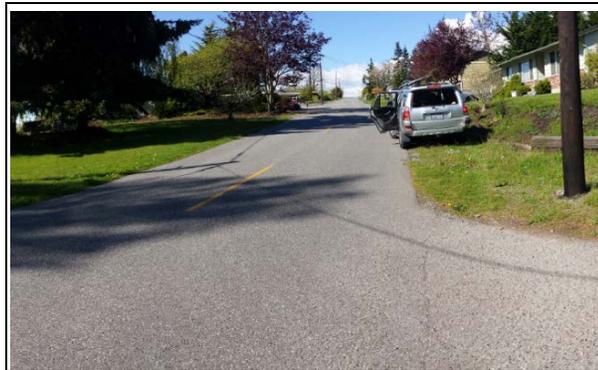
Figure 6-30 CIP Project #10 – 85th Drive NW Photos

Problem Description: There is no formal drainage system along 85th Drive NW and drainage from the City street routinely floods a private residence at the 27800 block. Three photos of the street are shown in Figure 6-30.

Photo looking south along 85th Drive NW from 27800 block.

Photo looking north along 85th Drive NW from 276th Place NW.

Project Description: This CIP solution will provide street drainage and resurfacing on 85th Drive NW between 280th Street NW and 276th Place NW. As part of the CIP, a piped conveyance system will be constructed along 85th Drive NW that will flow south, connecting to the proposed ditch at 276th Place NW to be constructed as part of Project #4.
